Cladding Assessment

Project Outline

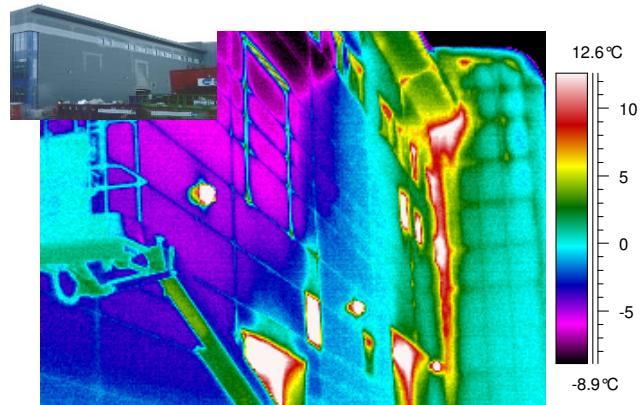
12 major regions of missing insulation were detected across the 2 buildings. Prior to the thermal survey, it was suggested that the ingress was originating from the flat roof. However, thermographic data found that the roof was in good condition with the ingress actually occurring at a cladding panel joint.

Areas of heat loss (in red and white) in the thermal image adjacent are indicative of poorly fitting cladding panels. The building plan pinpoints exactly where the heat loss is.

Thermal image showing heat loss at poor cladding junction

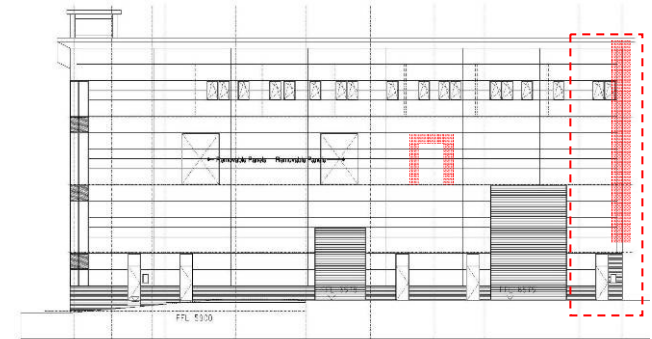
Building plan detailing heat loss regions on elevation in red.
